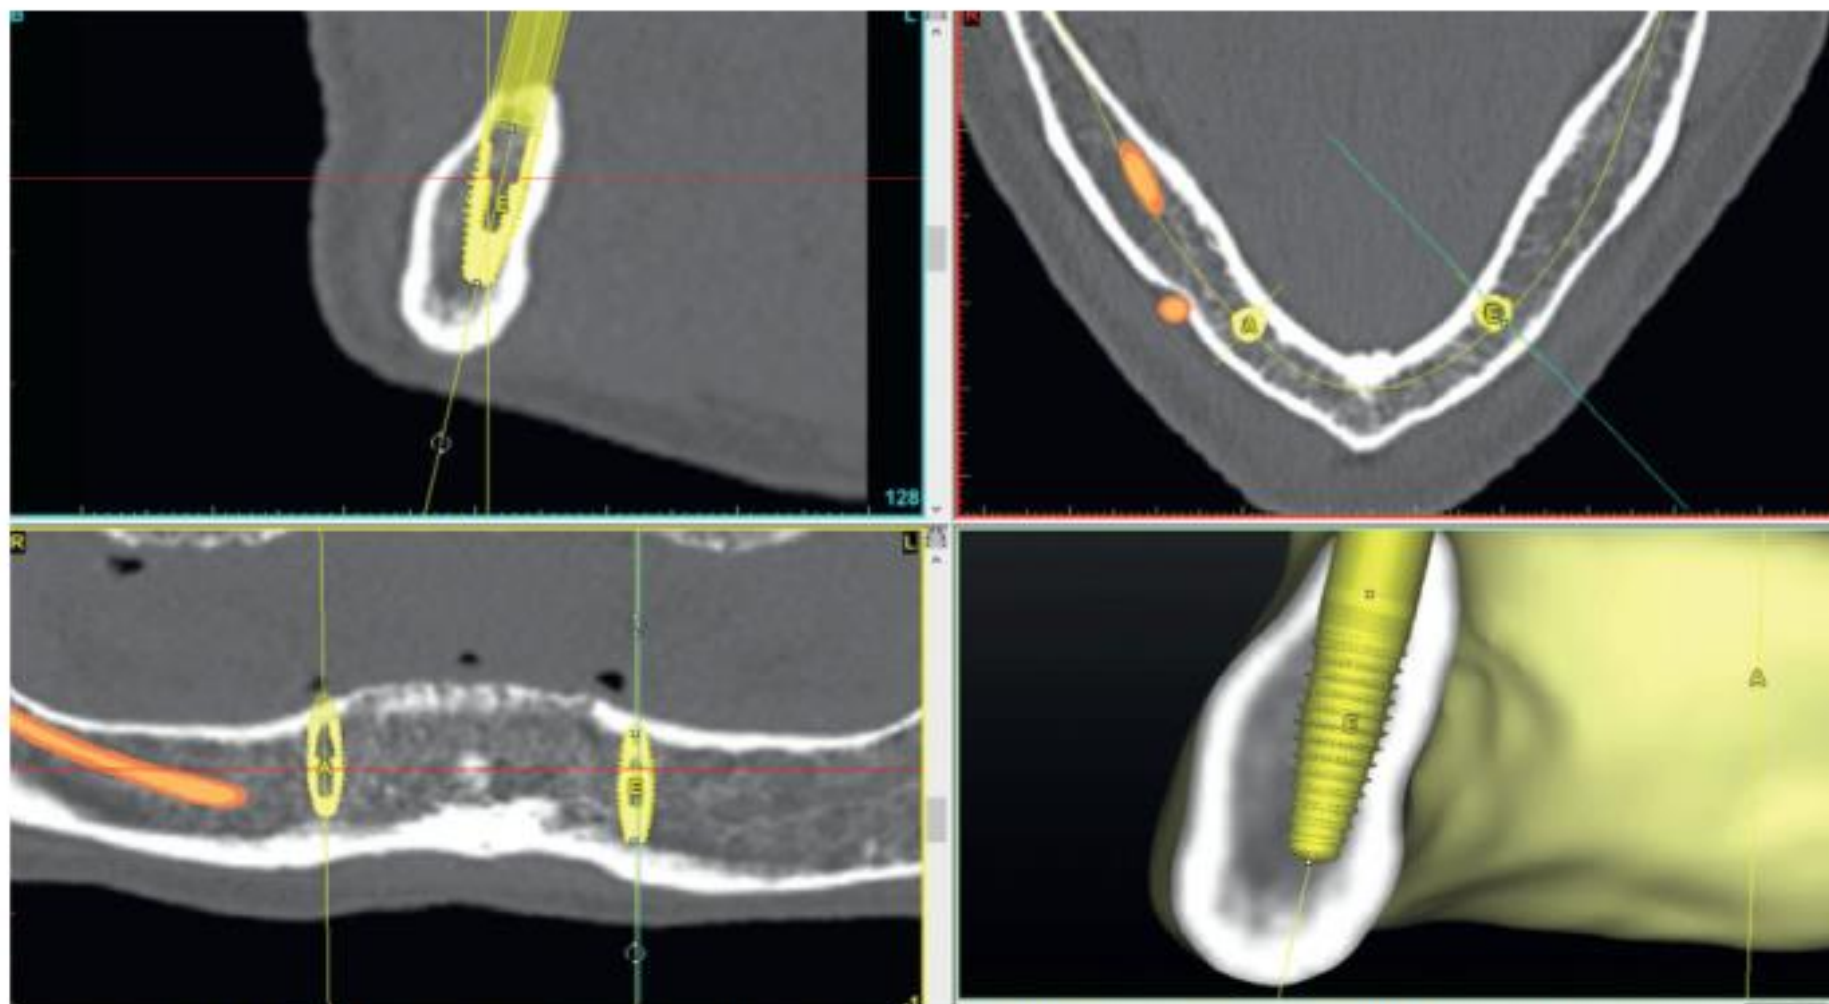
FIG 3.17 The anterior mandible has the greatest bone height of any region of the jaws. However, because of the variable osseous angulation in the anterior mandible, the implant often engages the lingual plate of bone.

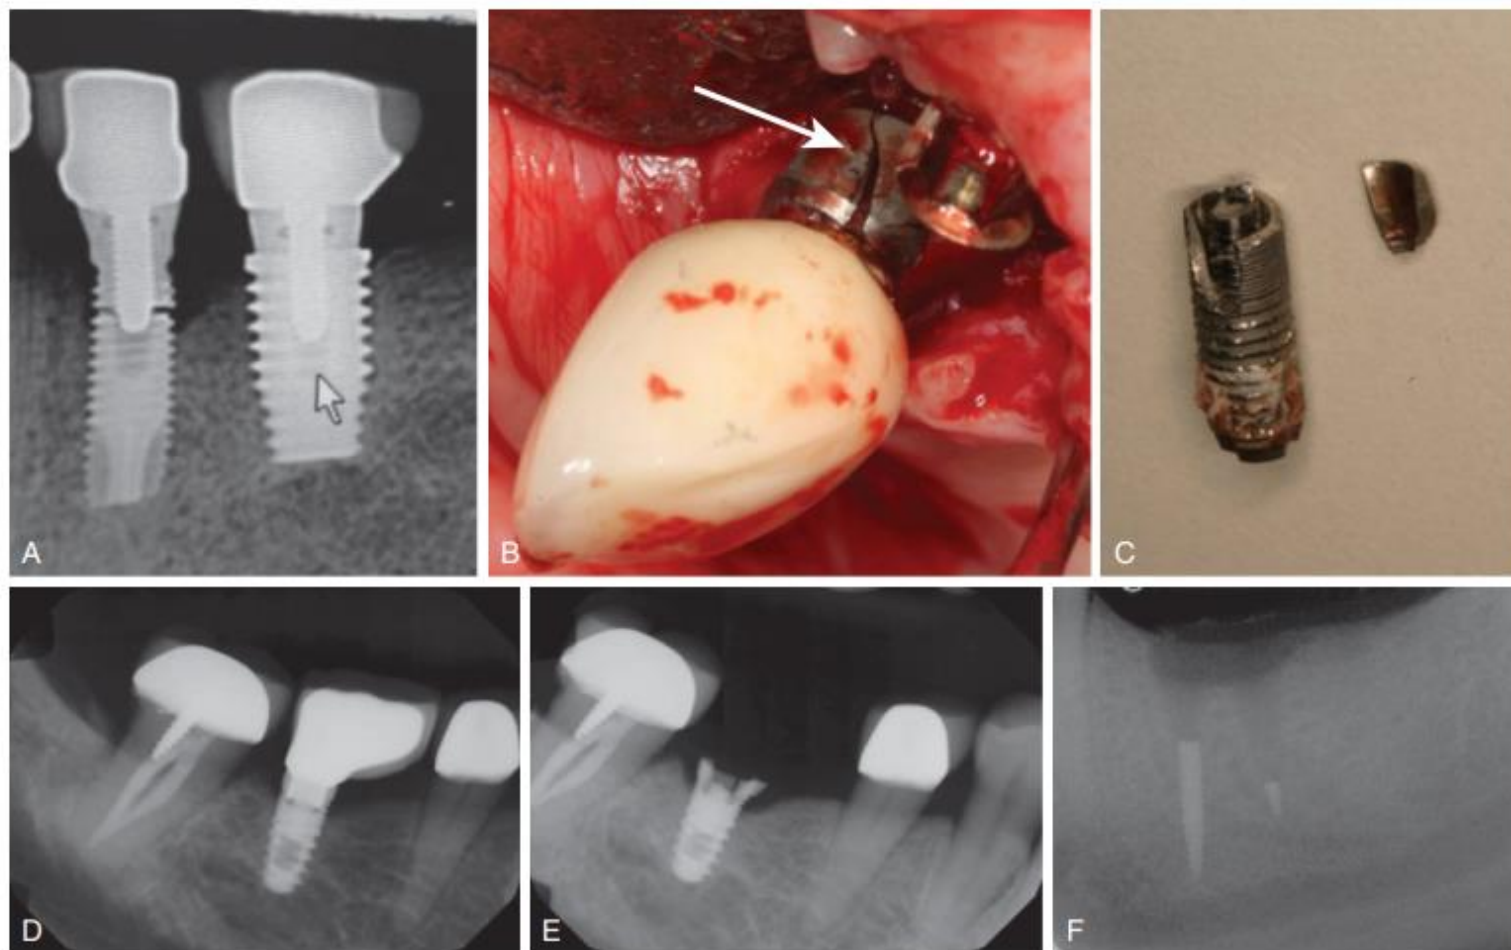
FIG 10.18 Fractured implant. (A) Implant body fracture. (B–C) Implant neck fracture. (D) Small diameter implant placed in a nonideal position, note mesial cantilever. (E) Because of small diameter implant, presence of mesial cantilever, internal hex neck fracture. (F) Two mini-implants fractured in the posterior mandible in close proximity to the mandibular canal.

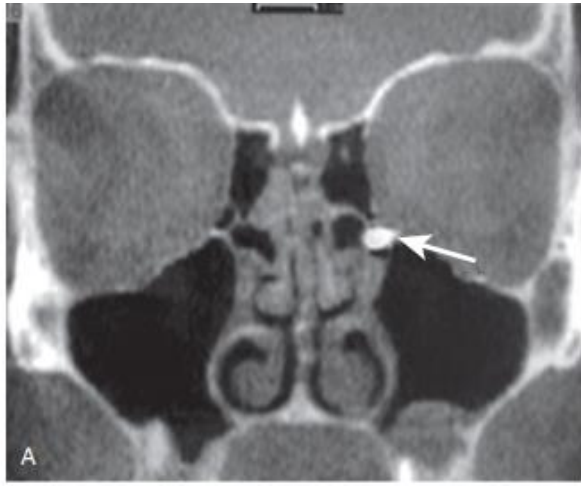
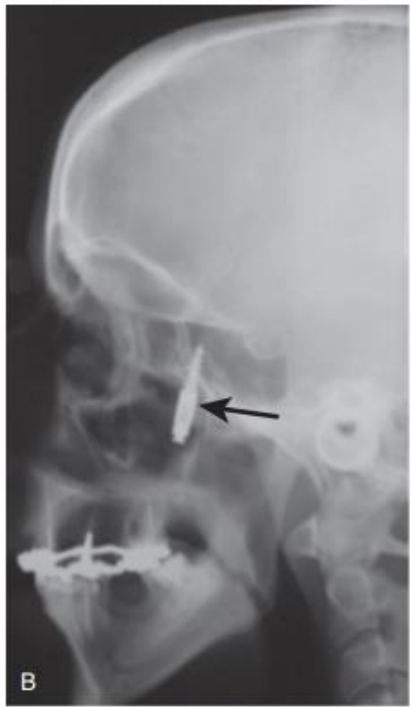
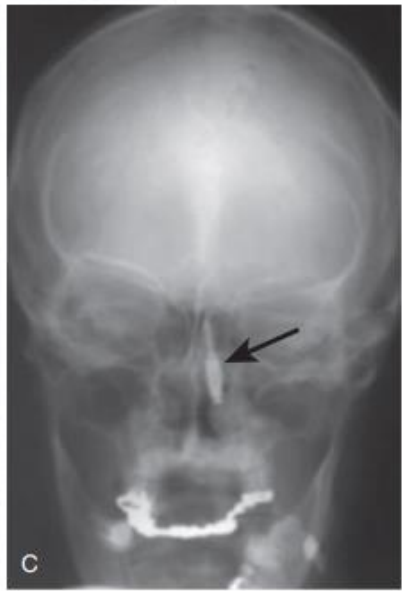
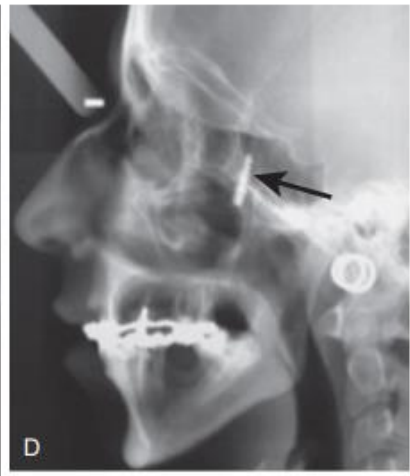
FIG 10.26 Migrated implants. (A) Ethmoid sinus. (B–D) Migrated implant into sphenoid sinus. (A, From Haben M, Baly S, Frenkiel S: Dental implant migration into the ethmoid sinus, *J Otolaryngol* 32:342–344, 2003; B–D, From Felisati G, Lozza P, Chiapasco M, et al: Endoscopic removal of an unusual foreign body in the sphenoid sinus: an oral implant, *Clin Oral Implants Res* 10:370–300, 2003)

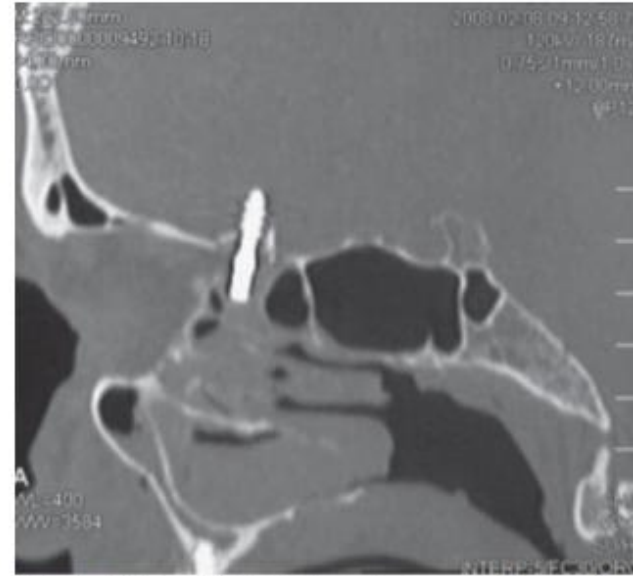
FIG 10.28 Migrated implants anterior cranial base. (From Cascone P, et al: A dental implant in the anterior cranial fossae, *Int J Oral Maxillofac Surg* 39:92–93, 2010.)

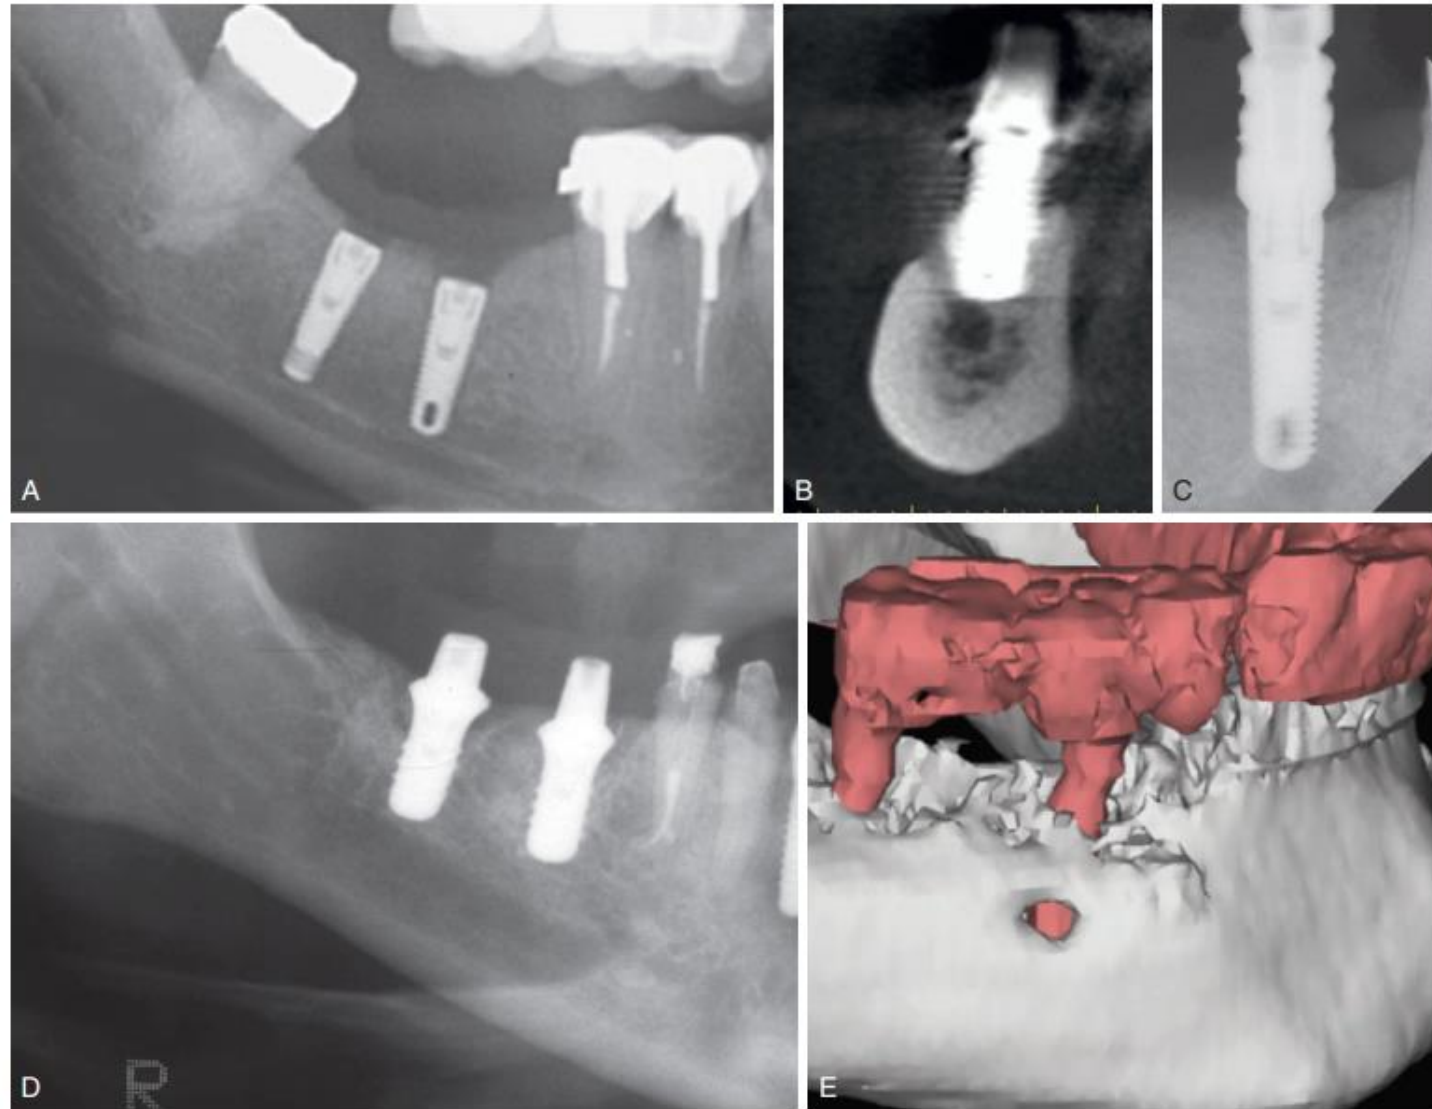
FIG 9.1 Neurosensory impairment of the inferior alveolar nerve. (A) Placement of two implants, completely transecting the mandibular canal. (B–C) Implant placement impinging on the mental foramen. (D) Immediate placement implant after premolar extraction causing nerve impairment. (E) CBCT image depicting implant placement through mandibular canal.

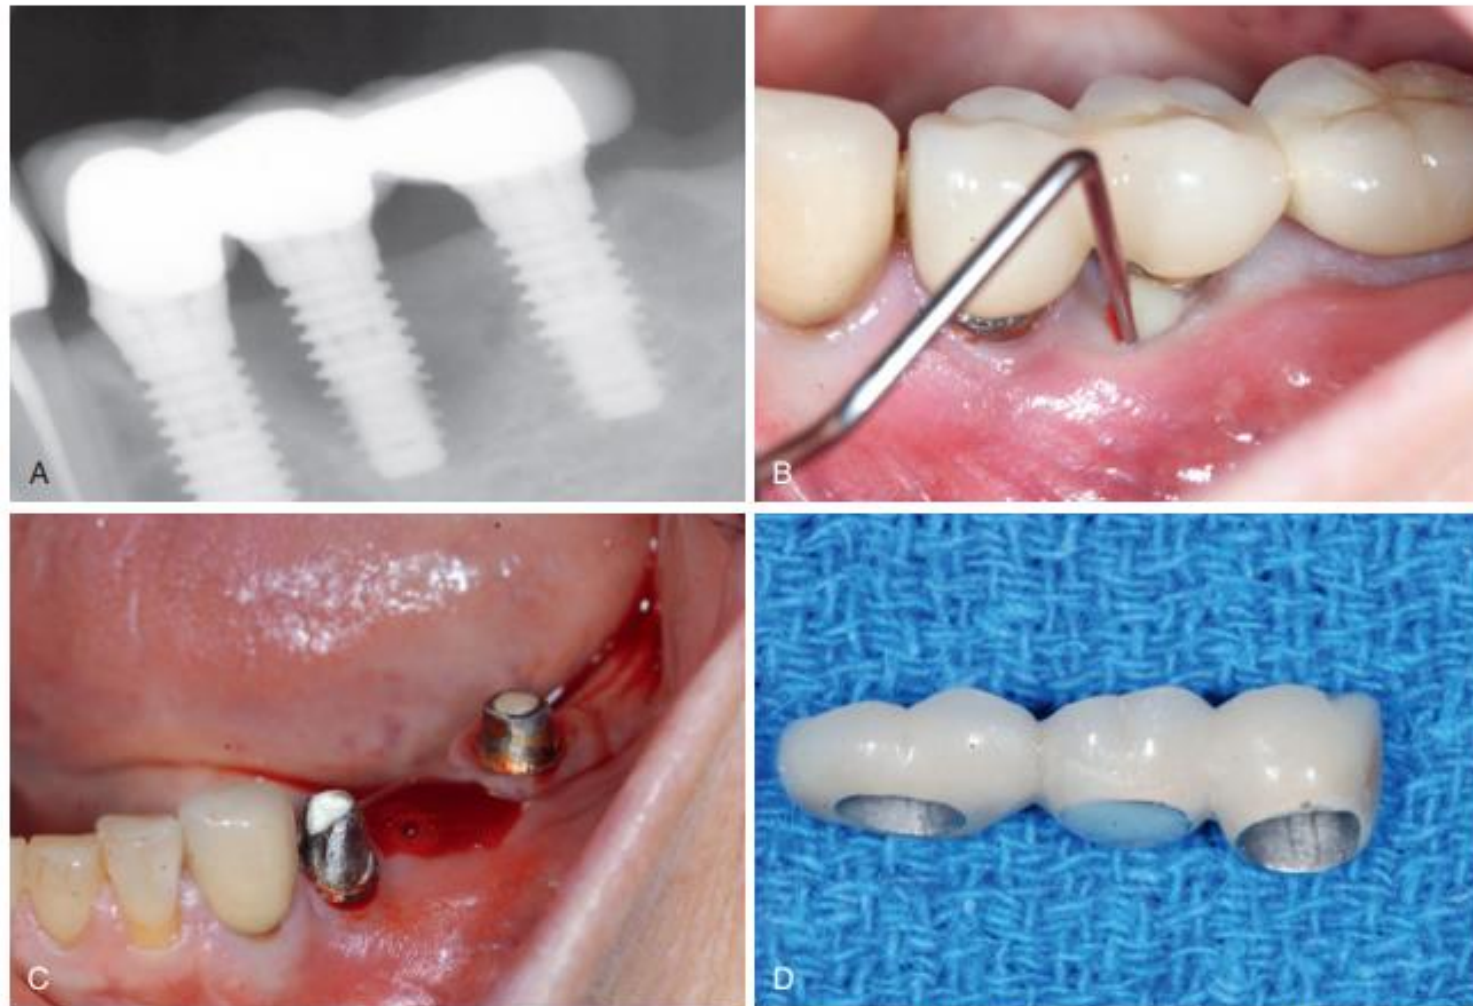
FIG 18.49 (A) Implants in group IV represent clinical failure and implants no longer in the mouth. The center implant in this radiograph is an implant with more than 50% loss; it is category IV. (B) The implant should be removed when group IV exudates are present. (C) The implant is removed from the site. The implant now is converted to group V (absolute failure). (D) The prosthesis is modified to become a three-unit fixed partial denture. (From Misch CE: *Dental implant prosthetics*, ed 2, St Louis, 2015, Mosby.)

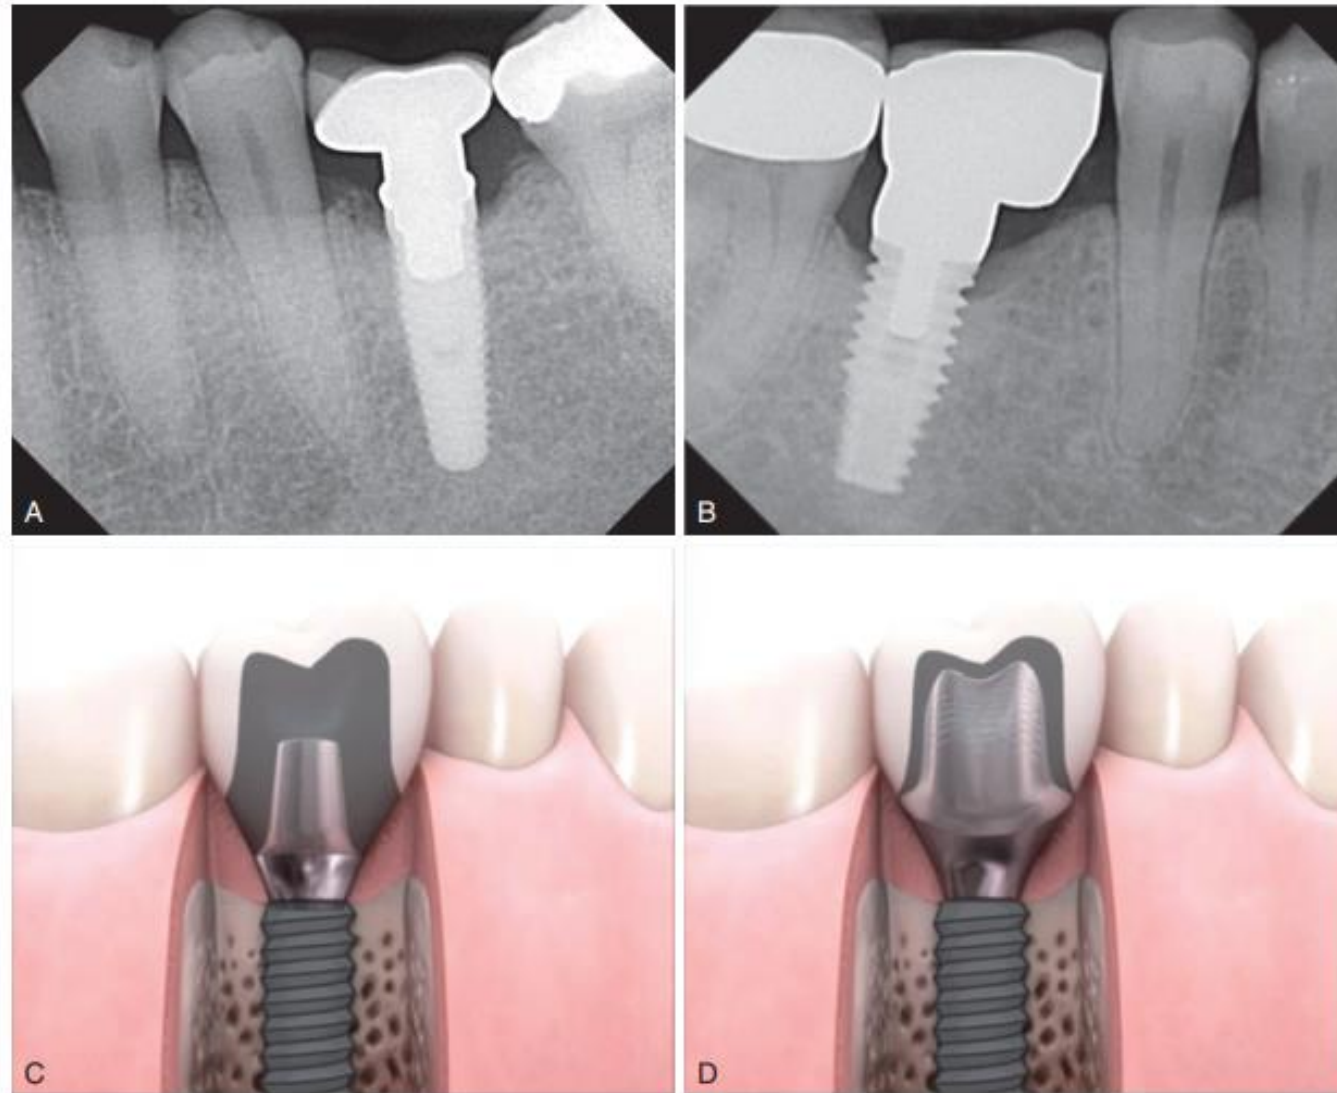
FIG 16.110 (A–B) Poor emergence profile. (C) Emergence profile is easily obtained via the prosthesis, (D) not necessarily a flared prefabricated abutment.

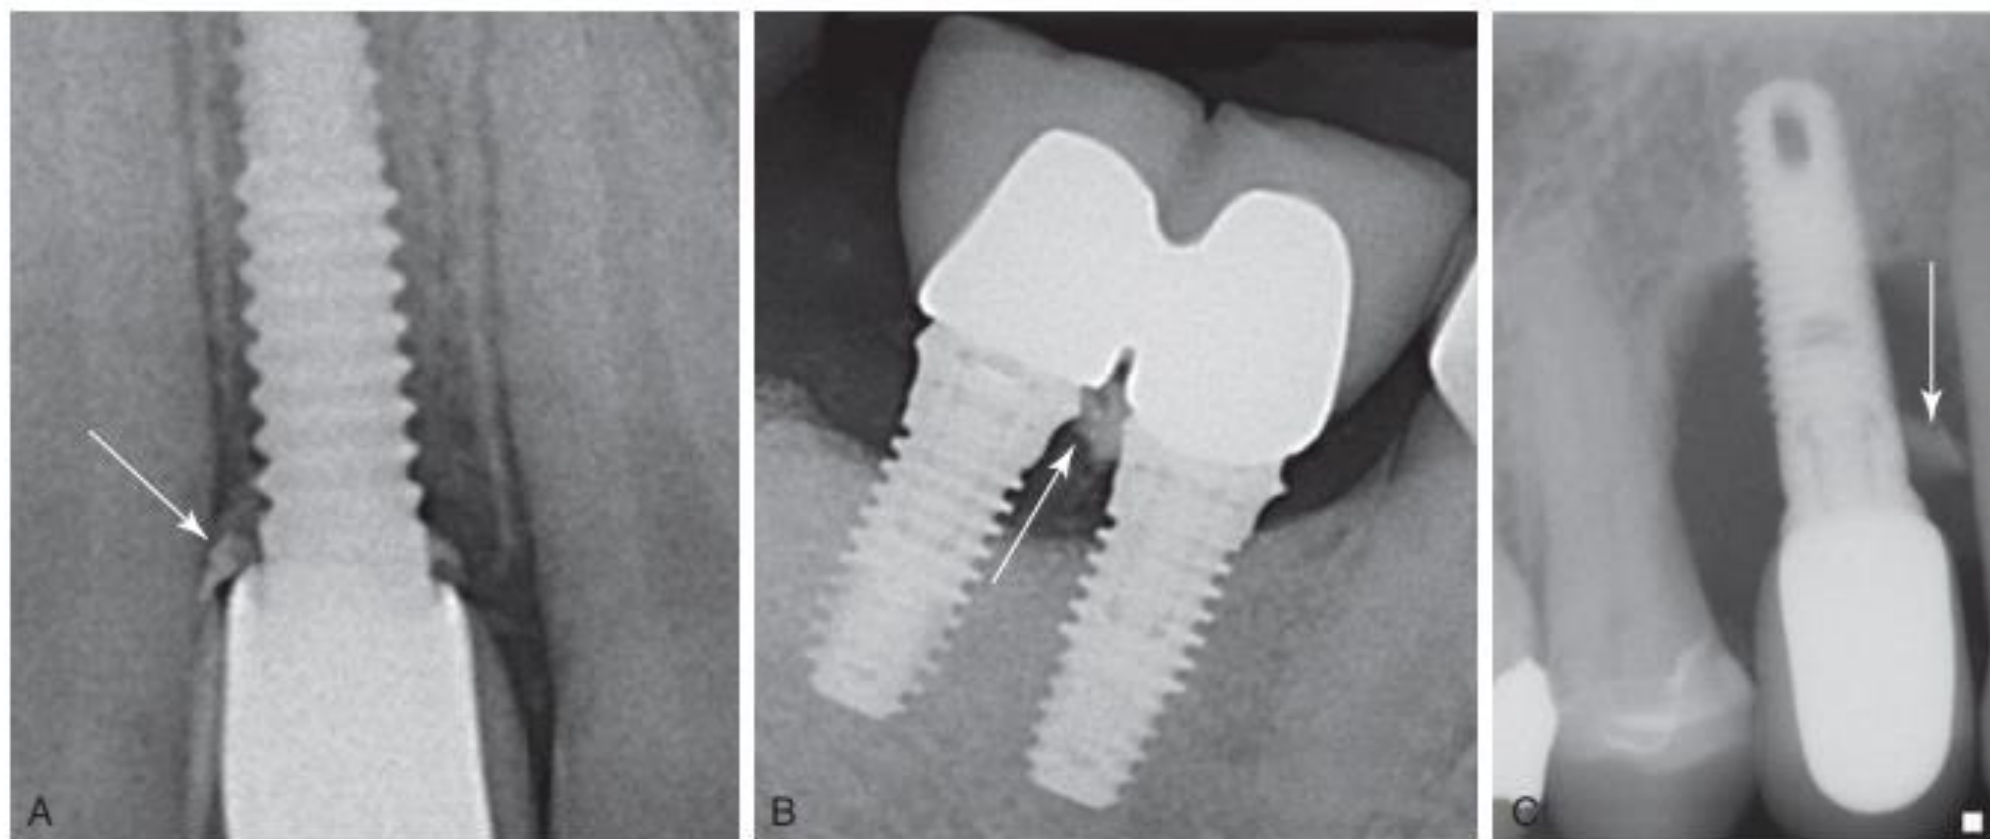
FIG 16.116 (A–C) Radiographic evaluation of cement retention; can only be seen on mesial and distal.

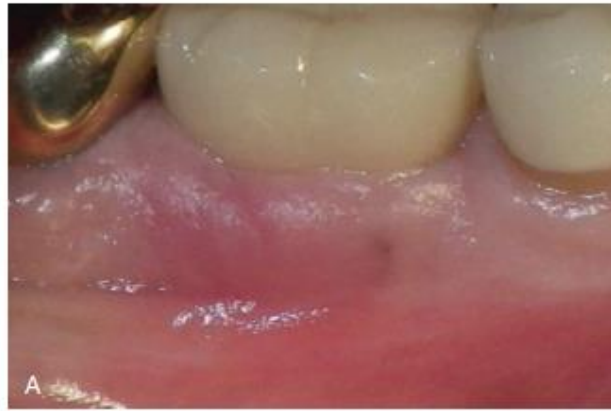
FIG 16.121 Treatment for retained cement. (A) Soft tissue irritation with chronic inflammation. (B) Radiographic confirmation of retained cement. (C) Treatment included surgical access for cement removal that included curettage, detoxification, and grafting.
